AD-A127 191 LIMITED ARTIFICIAL AND NATURAL ICING TEST OF THE OV-1D 1/1
(RE-EVALUATION)(U) ARMY AVIATION ENGINEERING FLIGHT

USAAEFA PROJECT NO. 81-21

MITED ARTIFICIAL AND NATURAL ICING TEST OF THE OV-1D (RE-EVALUATION)

FINAL REPORT

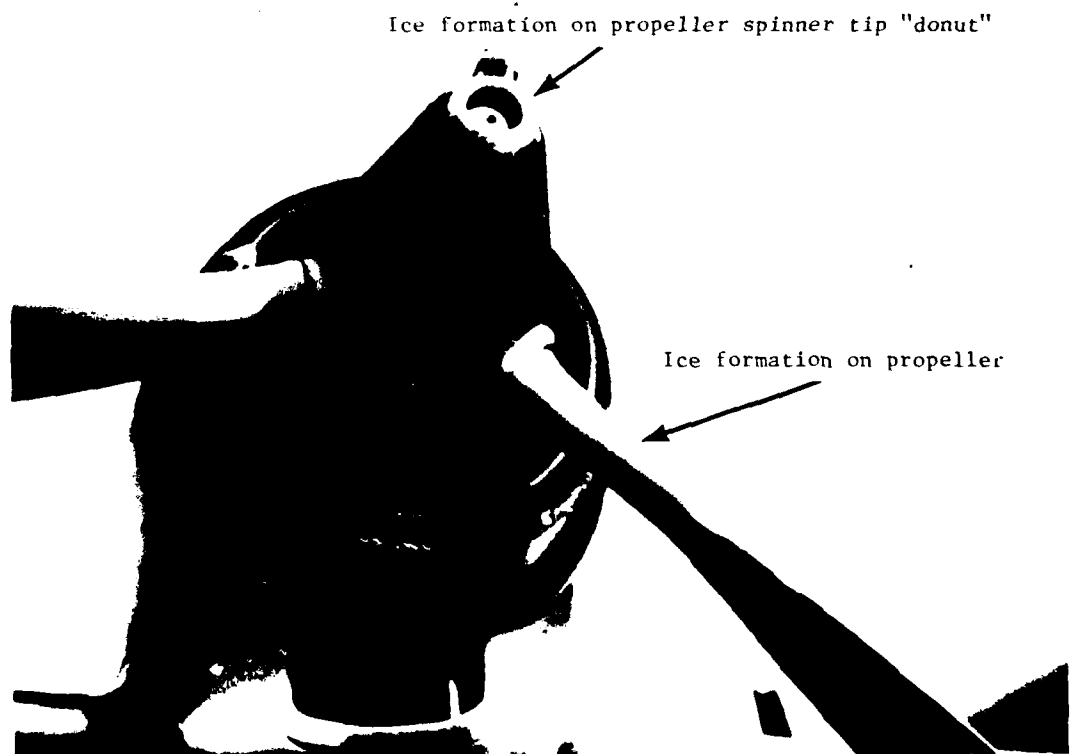
Photo 10. Artificial Icing, Phase II, -20°C , 0.59 gm/m^3

14. The propeller spinner ice accretion characteristics were evaluated at the conditions listed in table 2. Documentation is presented in photos 3, 9 and 10, appendix F. Some small slivers of ice formed on the sides of the spinner at temperatures colder than -12.5°C (photos 3 and 9). At all test conditions, ice formed on the forward end of the spinner. This ice was 1 to 2 inches thick and formed in the shape of a donut conforming to the shape of the spinner tip (photos 9 and 10). This ice departed the spinner when the outside air temperature was above freezing. Over a given period of time, the higher LWC's produced a larger ice donut on the tip of the prop spinner as compared to lower LWC's. However, no concrete correlation can be made to the thickness of the ice and LWC since particle size and frequency of ice sheds also influence the size of the donut. It is possible that this ice might be ingested through the engine inlet; however, this was never observed. On two occasions, the observer saw the ice depart. Flight conditions were 1500 feet per minute descent, low power, 1400 RPM propeller speed, and 150 knots indicated airspeed (KIAS). Both times, the ice donut departed over the cowl, well clear of the engine inlet. On one occasion it passed through the plane of the propeller intact. On the last flight, the duty cycle of the propeller spinner heating elements was reduced to allow more heating of the propeller butt boot. The final flight was at -20°C and evidence of changes in spinner ice accretion characteristics was inconclusive. The formation of ice on the propeller spinner tip is a shortcoming.

15. The ice accretion characteristics of the propeller blades were evaluated at the conditions in table 2. Photographic documentation is presented in photos 10 through 12, appendix F. Ice formed on the propeller, butt boots, and blades at all conditions tested. At -20°C ice accreted on the blade to about

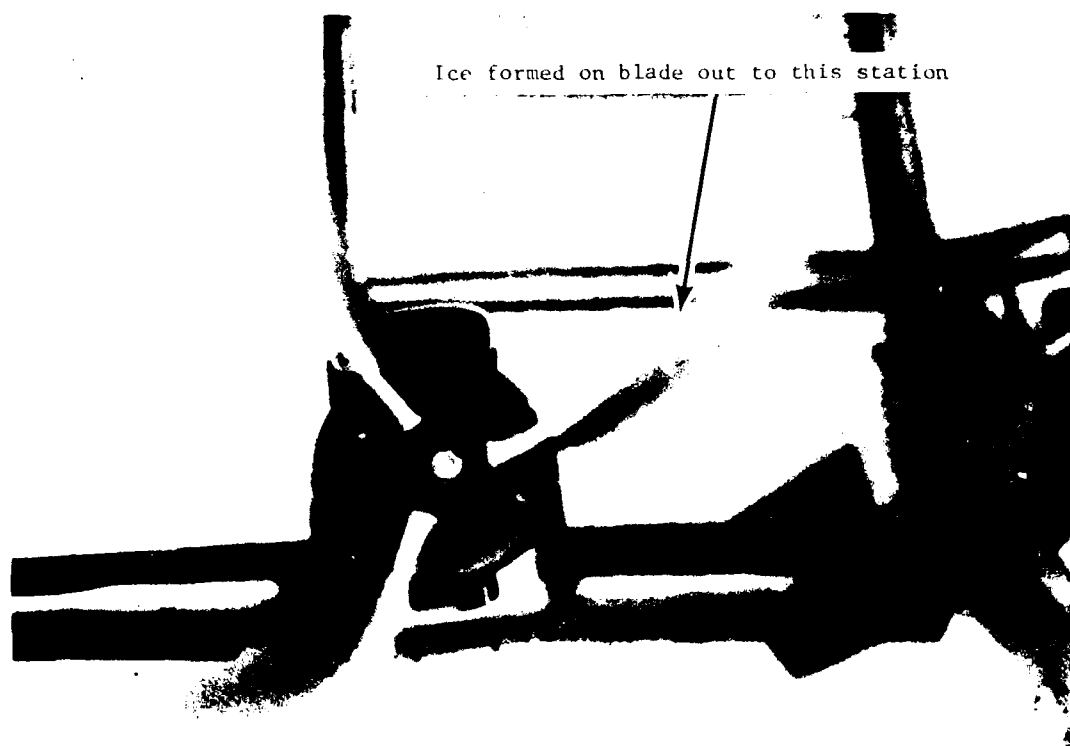
Photo 11. Artificial Icing, Phase 11, -20°C , 0.59 gm/m

75 percent span (photo 11). Ice thickness up to 1-1/2 inches on the blade was measured after landing (photo 12). It was not possible to document the thickness of the ice which accreted on the prop at all test conditions due to in flight shedding. The propeller butt boot, which is electrically deiced, accreted ice as if it were not heated. For the last flight, the duty cycle of the blade butt boot was increased 400 percent. There was no observed improvement. This is probably due to the heat sink capacity of the aluminum blade dissipating the heat energy of the boot before it could melt the ice bond. The propeller blades randomly shed ice which created moderate air frame vibrations and damaged the skin of the fuselage and drop tank. Damage to the airframe and stores caused by ice shedding from the propellers is a shortcoming.

Ice on blade butt boots

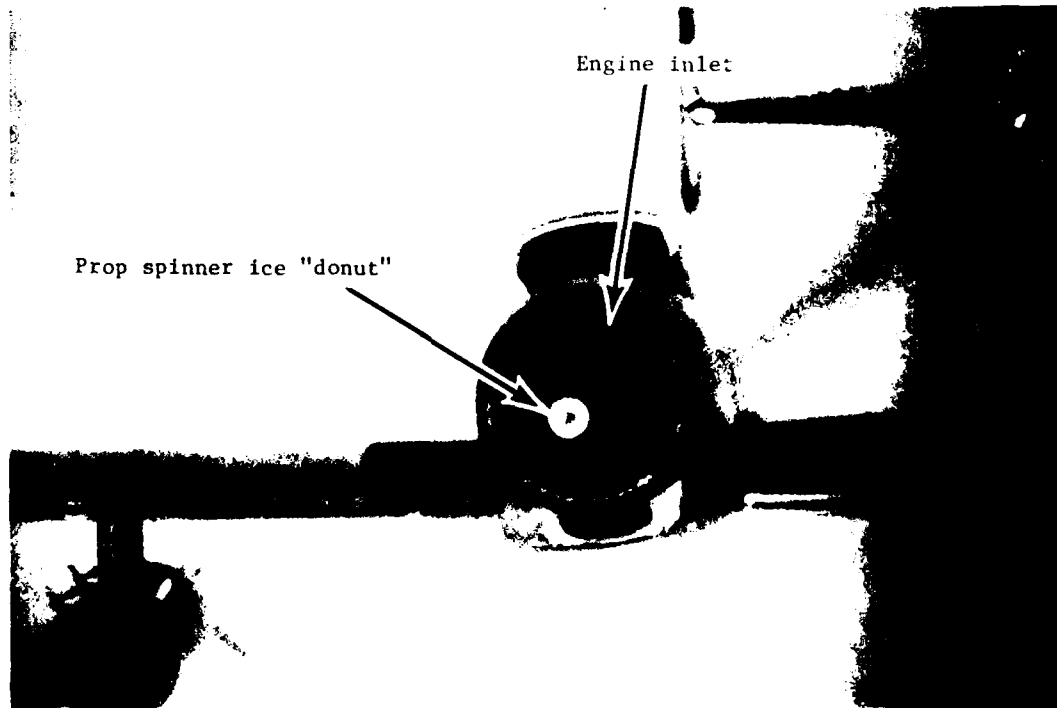
20. Documentation of the No. 1 and No. 2 engine nose cowling assembly ice accretion characteristics is presented in photos 13 through 15, appendix F. A small piece of ice, approximately 1/4-inch wide and 1/4-inch thick, accreted on the No. 1 engine inboard cowling half joint leading edge at each of the conditions tested. A typical ice accretion on the inboard cowling half joint is shown in photo 13. This ice would periodically break-off and was probably ingested into the engine although no engine damage was observed during post flight inspections. An ice formation occurred on the No. 1 engine cowling half joint, but not on the No. 2 engine. This could be due to lower heat transfer to this area since on the No. 1 engine, element D1 is ON only 50 percent of the time and/or the gap between the fixed and removable cowl halves was greater than the No. 2 engine. Both engine cowling struts and inlet interior appeared to be free of ice as viewed from the chase aircraft (photos 14 and 15, app F). The No. 2 engine inlet including the cowling half joints, leading edge, inlet interior, and cowling struts appeared to be free of ice at the conditions tested. The absence of ice on the cowl half joint leading edge of the No. 2 engine is probably due to better heat transfer in this area resulting from element D1 being ON continuously and/or the closer fit between the fixed and removable cowl halves. The Phase III configuration of the No. 2 engine nose cowling assembly exhibited the best ice accretion characteristics of all the configurations tested. However, ice still forms on the Phase III configured No. 1 engine cowling joints and extends around the leading edge of the cowling where it could break off and cause engine damage and is a shortcoming. It should be noted that -13°C was the coldest natural icing condition tested. Past experience has shown the colder the ambient temperature the more heat required to keep the inlet free of ice. Since natural icing conditions may be found at temperatures colder than -13°C, consideration should be given to further natural icing tests to evaluate the ice accretion characteristics at colder temperatures.

Photo 14. Natural Icing, Phase III, -13°C , 0.2 gm/m^3 , No. 2 engine

Photo 15. Natural Icing, Phase III, -13°C , 0.2 gm/m^3 , No. 1 Engine
